2022 BI-ANNUAL ENVIRONMENTAL COMPLIANCE AUDIT **REPORT**

TETRA4 CLUSTER 1 ONSHORE GAS PRODUCTION FACILITY NEAR VIRGINIA,
FREE STATE PROVINCE

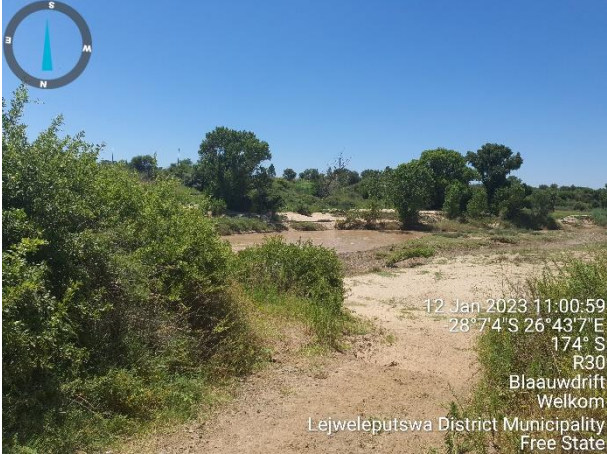
<p>10 ✓</p>	<p>Directional drilling was conducted at the Sand River and no impacts could be determined during the Audit as conducted on 12 January 2023.</p>

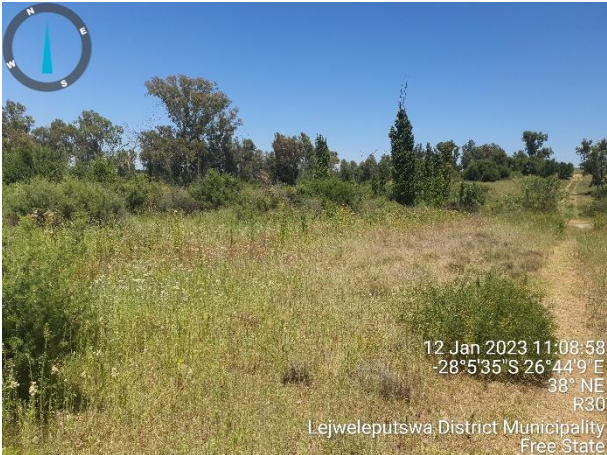
<p>11 ✓</p>	<p>The concrete ford can be observed within the background which was constructed over the watercourse. Furthermore, vegetation has established at the areas disturbed during the installation of the pipeline.</p>

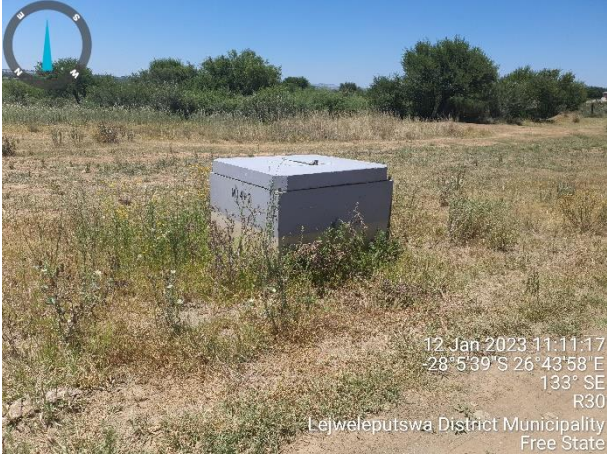
<p>12 ✓</p>	<p>Low point drains where moisture within the pipeline accumulates to be pumped out and disposed of are kept to the smallest footprint possible.</p>

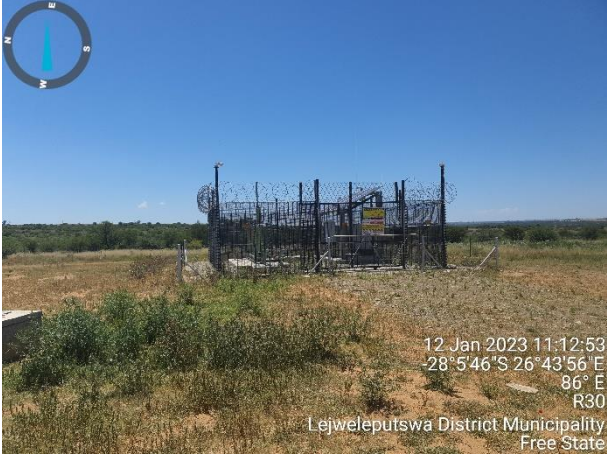
<p>13 ✓</p>	<p>Photo No. 13 illustrates a completed well which is completely fenced off to ensure fauna species can't enter the site. Furthermore, the well is fitted with a motion sensor which sounds an alarm if someone comes too close. A notification is then sent to the Control Room who can access a video feed and turn off the alarm.</p>
---	------------------------	--
