## **2023 BI-ANNUAL ENVIRONMENTAL COMPLIANCE AUDIT** **REPORT**

TETRA4 CLUSTER 1 ONSHORE GAS PRODUCTION FACILITY NEAR VIRGINIA,  
FREE STATE PROVINCE

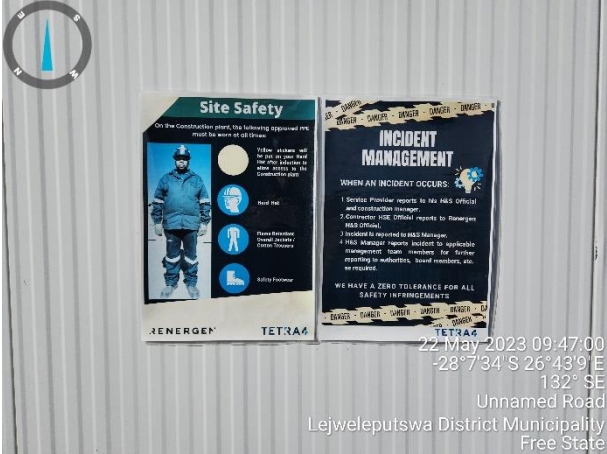
PHOTOGRAPH	NUMBER & COMPLIANCE	DETAILS
	<p>1 ✓</p>	<p>PPE and Health and Safety Signs are visible through-out the facility. Furthermore, all visitors are escorted by an employee of Tetra4 when entering the site and induction training is provided beforehand.</p>
	<p>2 ✓</p>	<p>Fire Fighting equipment is readily available throughout the facility and serviced on a regular basis.</p>

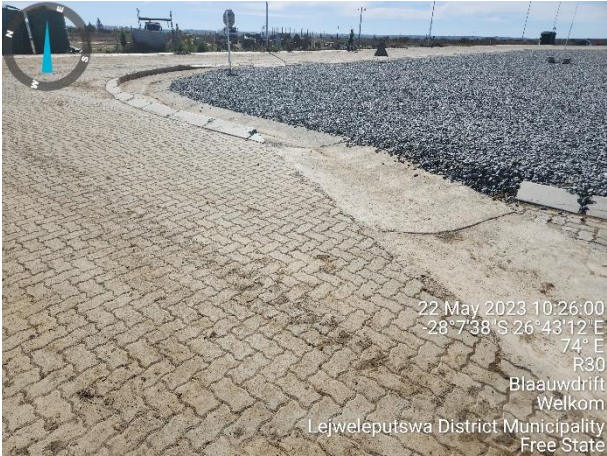
<p>9 ✓</p>	<p>Stormwater canals were developed on site to ensure the separation of clean- and dirty water on site. The canals were developed in line with the Stormwater Management Plan.</p>

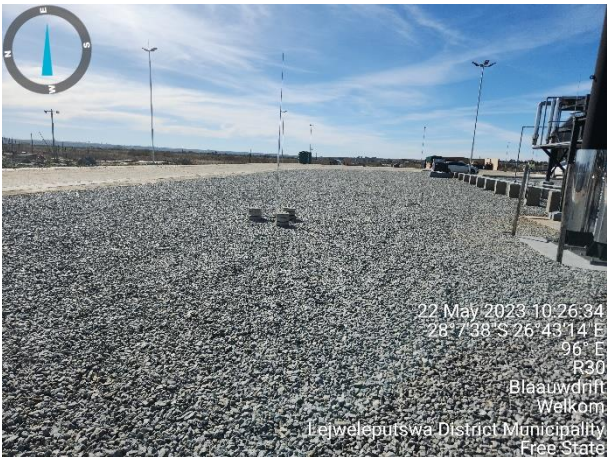
<p>10 ✓</p>	<p>The site surrounding the plant has been landscaped with gravel and cleared of all vegetation as a pre-cautionary measure in the event of fire.</p>

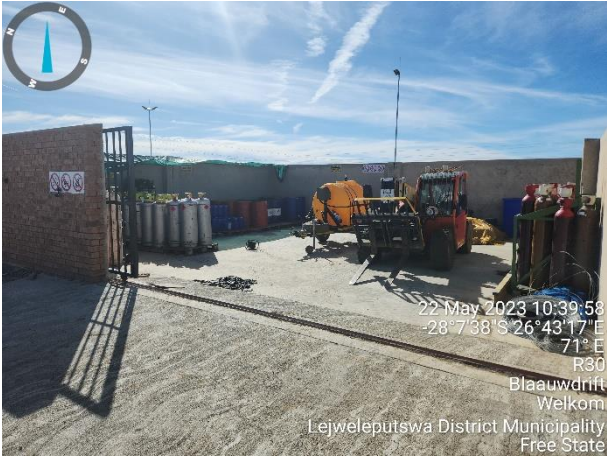
<p>11 ✓</p>	<p>Hazardous substances are stored within a dedicated storage area which consist of an impermeable chemical resistant floor, hard walls and lockable gate. Furthermore, the storage area is well ventilated.</p>

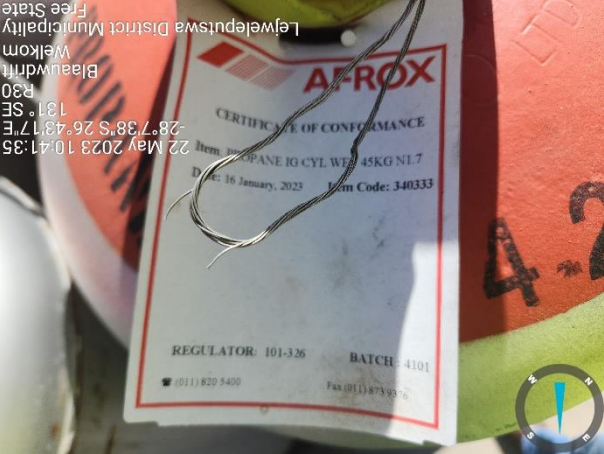
<p>22 May 2023 10:41:35 -28°7'38"S 26°43'17"E 131° SE R30 Blaauwdrift Welkom Lejweleputswa District Municipality Free State</p>	<p>12 ✓</p>	<p>All LPG Cylinders are accompanied by a Certificate of conformance as illustrated within Photo Position 12.</p>

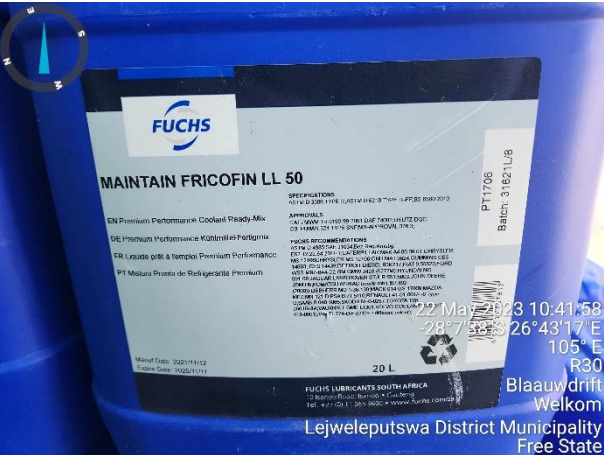
<p>22 May 2023 10:41:58 -28°7'38"S 26°43'17"E 105° E R30 Blaauwdrift Welkom Lejweleputswa District Municipality Free State</p>	<p>13 ✓</p>	<p>All hazardous substances are sealed, content identified and MSDS Files are readily available on site and filed within the Environmental File.</p>

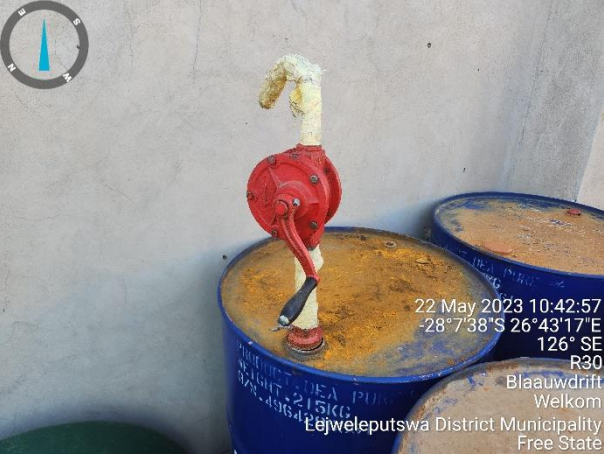
<p>22 May 2023 10:42:57 -28°7'38"S 26°43'17"E 126° SE R30 Blaauwdrift Welkom Lejweleputswa District Municipality Free State</p>	<p>14 ✓</p>	<p>Pre-cautionary measures such as hand pumps and drip trays are utilised within the LNG Plant.</p>

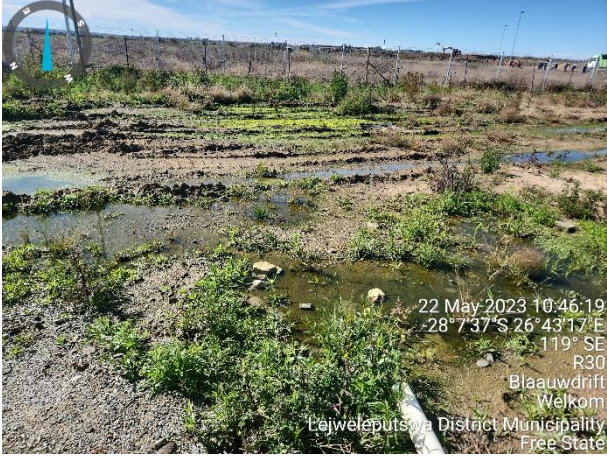
AREA:	DETAILS:	MINOR/ MAJOR/ INTERMEDIATE	PHOTO REF.	RESPONSIBILITY
WASTE STORAGE AREA	It must be ensured that all waste areas/skips are covered with a roof or lid structure.	MINOR	-	TETRA4: OWNER AND MANAGER
ADMINISTRATION	No proof was provided that all MSDS Files were submitted to the PASA 60 days prior to the commencement of Drilling Operations.	MINOR	-	
LNG PLANT	An Integrated Wastewater Management Plan (Document Ref. No.: EIMS 1109) and Waste Management Procedure (Dated March 2018) is readily available on site and filed on the cloud based server. The Waste Management Procedure incorporates waste avoidance, reduction, recycling, treatment, re-use and disposal. A Grievance Procedure is readily available on site and all grievance are captured by the CLO. Ablution facilities are readily available within walking distance from all working station. It must be noted that sewage is spilled within the LNG Plant.	MAJOR	15

<p>22 May 2023 10:46:19          -28°7'37"S 26°43'17"E          119° SE          R30          Blaauwdrift          Welkom          Lejweleputswa District Municipality          Free State</p>	<p>15 X</p>	<p>Sewage water is currently leaking on site. It must be noted that Tetra4 are investigating various alternatives to address the issue at hand.</p>

The sewage spill that occurred within the LNG Plant must be cleaned, the incident investigated and mitigation measures implemented within 30 days of the Audit Report.

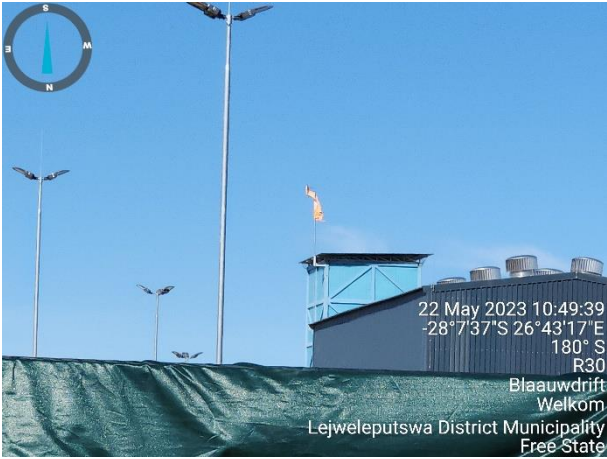
<p>22 May 2023 10:49:39          -28°7'37"S 26°43'17"E          180° S          R30          Blaauwdrift          Welkom          Lejweleputswa District Municipality          Free State</p>	<p>16 ✓</p>	<p>A windsock was installed on site as per the requirement stipulated within the Environmental Management Plan and Environmental Authorisation.</p>

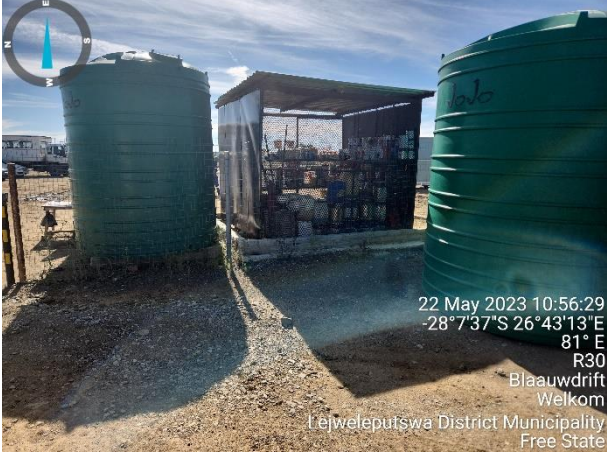
<p>22 May 2023 10:56:29          -28°7'37"S 26°43'13"E          81° E          R30          Blaauwdrift          Welkom          Lejweleputswa District Municipality          Free State</p>	<p>17 ✓</p>	<p>Hazardous substances of the Sub-Contractor are stored within a dedicated storage area which consist of an impermeable chemical resistant floor, a bund area able to contain 110% of the volume stored within and covered with a roof structure.</p>

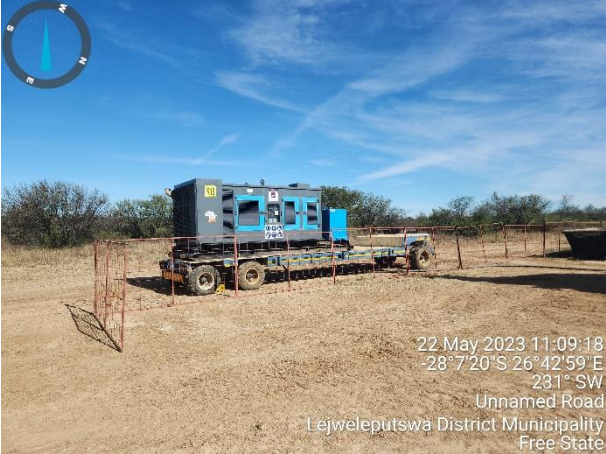
<p>22 May 2023 11:09:18          -28°7'20"S 26°42'59" E          231° SW          Unnamed Road          Lejweleputswa District Municipality          Free State</p>	<p>18 ✓</p>	<p>Generators used on site are equipped with internal drip trays able to contain 110% of the fuel stored within the tank.</p>

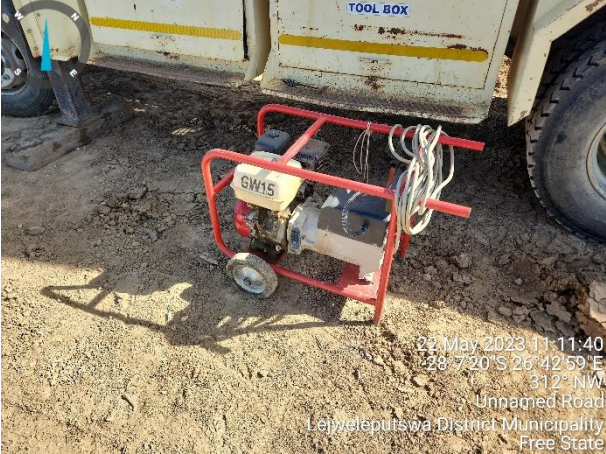
<p>22 May 2023 11:11:40          -28°7'20"S 26°42'59" E          312° NW          Unnamed Road          Lejweleputswa District Municipality          Free State</p>	<p>19 X</p>	<p>Drip trays were not placed beneath all stationary construction equipment. It must be noted that the generator in question was mechanically sound, and no leaks/spillages were observed.</p>

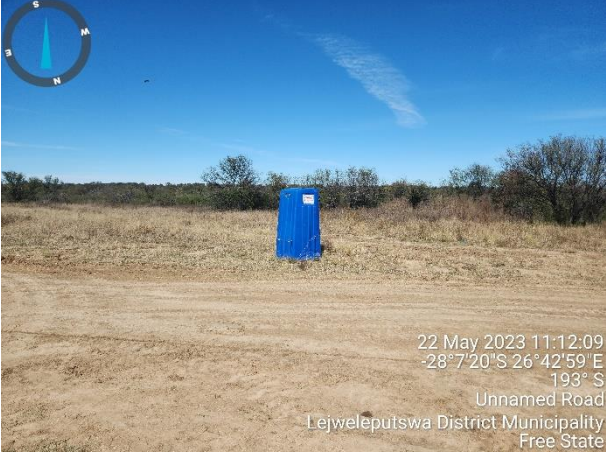
<p>22 May 2023 11:12:09          -28°7'20"S 26°42'59" E          193° S          Unnamed Road          Lejweleputswa District Municipality          Free State</p>	<p>20 ✓</p>	<p>Ablution facilities are readily available at all drilling sites and within walking distance from the site.</p>
