2024 BI-ANNUAL ENVIRONMENTAL COMPLIANCE AUDIT

TETRA4 CLUSTER 1 ONSHORE GAS PRODUCTION FACILITY NEAR VIRGINIA,
FREE STATE PROVINCE

Date: 15 September 2024

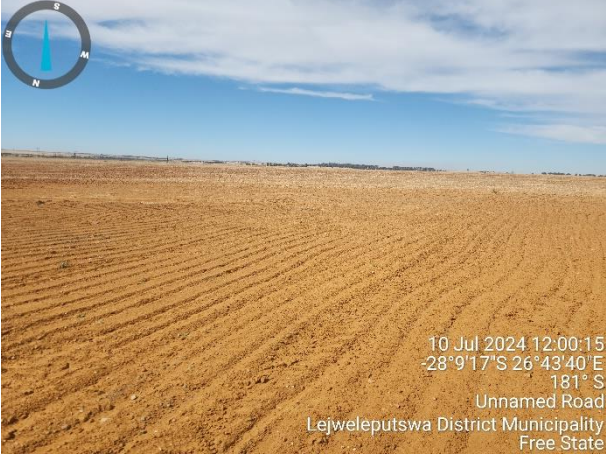
<p>3 ✓</p>	<p>All wells are limited to the development footprint to ensure minimal disturbance to agricultural activities and farmland.</p>

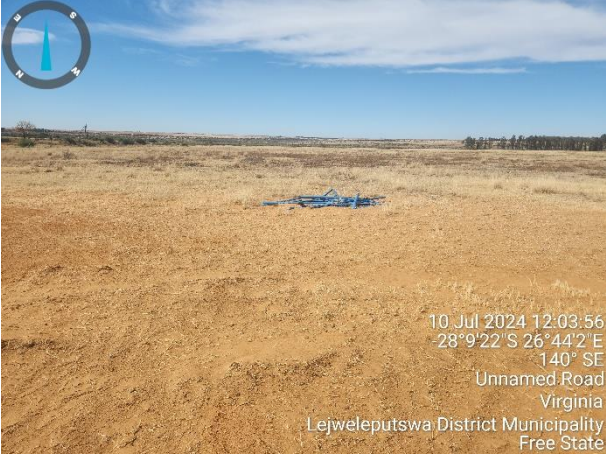
<p>4 X</p>	<p>During the time of the audit, pipeline installations were taking place on site. It must be ensured that all piping is removed from site once the installations are completed.</p>
 	<p>5 ✓</p>	<p>Sediment pits are readily available on site and are lined with HSPE linings to ensure that no ground contamination takes place.</p>

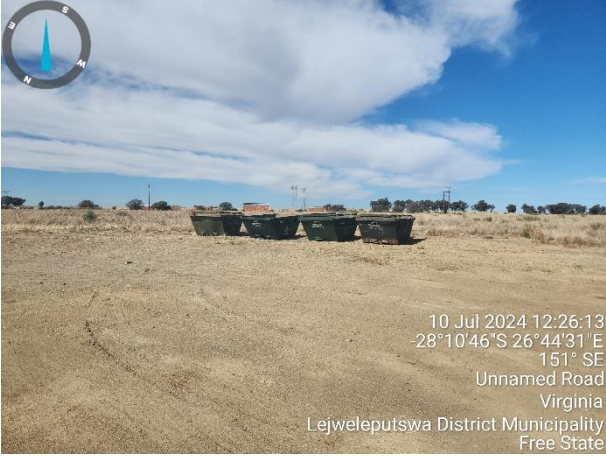
<p>9 ✓</p>	<p>Waste skips are readily available at all drilling sites and waste is removed by a registered waste contractor. It must be noted that skips were not covered with a lid.</p>

All skips within the waste area must be fitted with lids by 30 November 2024. Furthermore, a dedicated waste area must be created on site which consist of an impermeable surface, bund area able to contain 110% of the volume stored within, lockable gate and roof structure. All construction- and drilling- waste must be removed from the drilling sites and within the plant boundaries by the end of Quarter 4 of 2024.

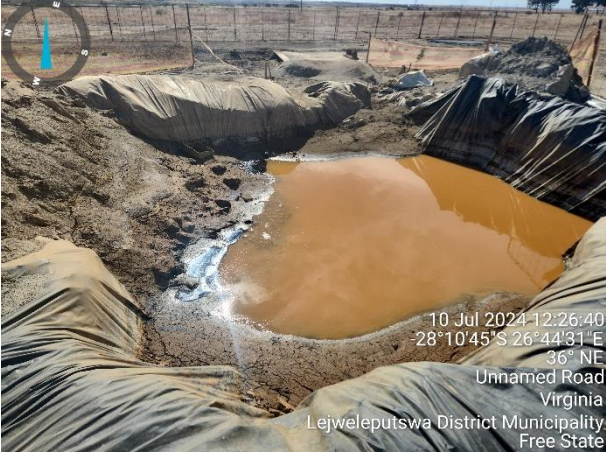
<p>10 ✓</p>	<p>Sediment pits are readily available on site and are lined with HSPE linings to ensure that no ground contamination takes place.</p>

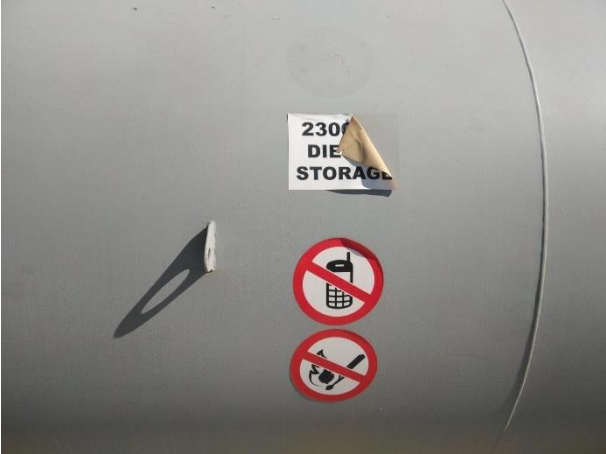
<p>12 X</p>	<p>Adequate safety signage is displayed at all hazardous tanks; however, some of the signage have started to tear from the structure.</p>

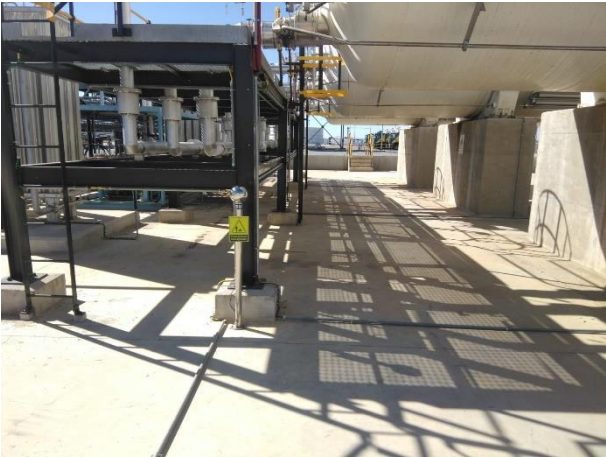
<p>13 ✓</p>	<p>All LNG Tanks are adequately bund which can accommodate 110% of the volume stored within. Furthermore, these bund areas do consist of an impermeable surface.</p>

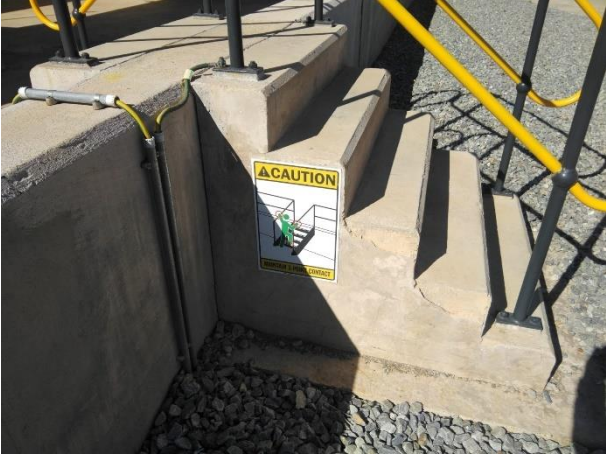
<p>14 ✓</p>	<p>Adequate safety signage is readily available and on displayed on site warning all personnel and visitors of the possible tripping hazards.</p>

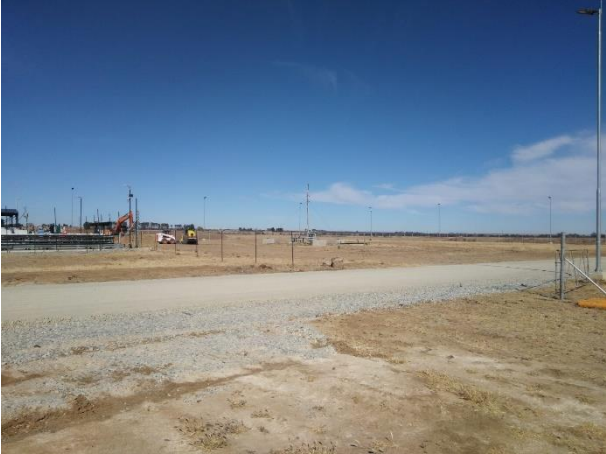
<p>15 ✓</p>	<p>A Gas Flare is readily available on site and used when and as necessary.</p>

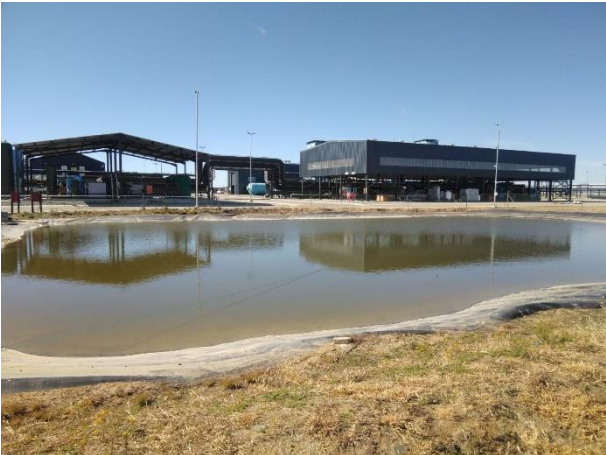
<p>16 ✓</p>	<p>An Evaporation Pond is readily available on site and utilised for all waste water generated on site.</p>

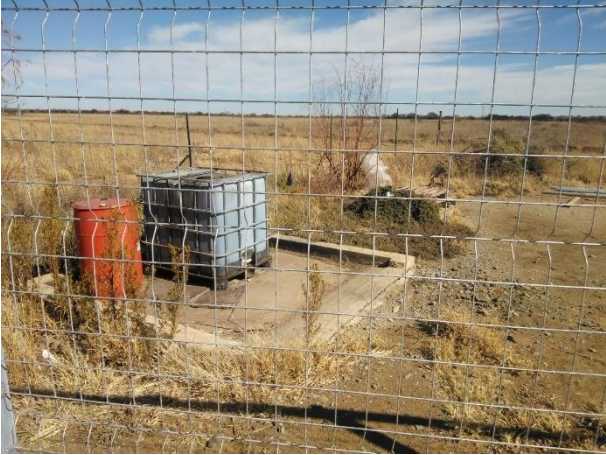
<p>17 X</p>	<p>Hazardous waste on site is incorrectly stored. All hazardous waste must be stored within a dedicated area which consist of an impermeable surface, bund area able to contain 110% of the volume stored within, roof structure and lockable gate. Furthermore, all waste containers must be sealed and the content identified.</p>

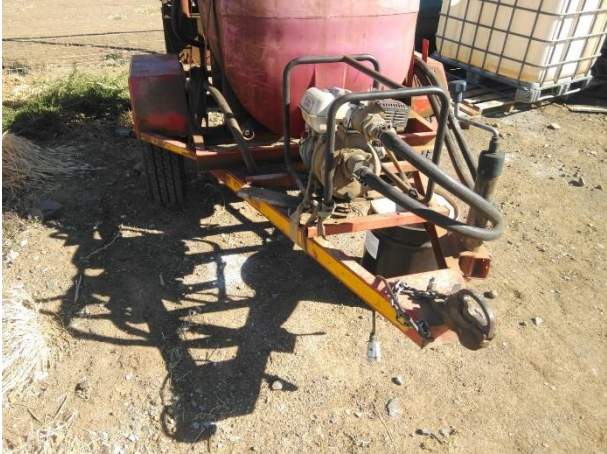
<p>18 X</p>	<p>It must be ensured that drip trays are placed beneath all stationary site equipment to ensure that no groundwater contamination takes place on site.</p>

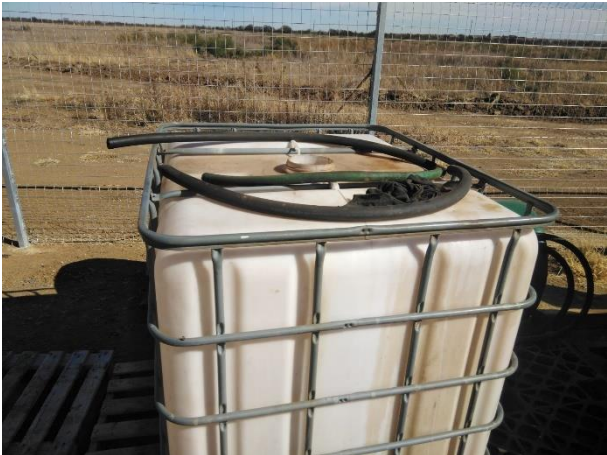
<p>19 X</p>	<p>All containers on site must be sealed and the content identified. Furthermore, it must be ensured that all containers are stored within dedicated storage areas.</p>

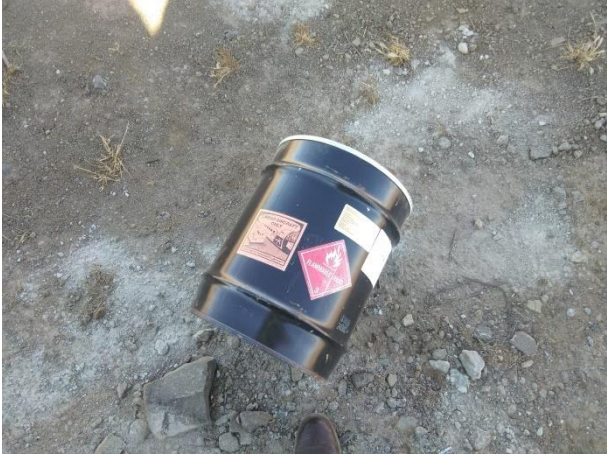
<p>20 X</p>	<p>Hazardous waste on site is incorrectly stored. All hazardous waste must be stored within a dedicated area which consist of an impermeable surface, bund area able to contain 110% of the volume stored within, roof structure and lockable gate. Furthermore, all waste containers must be sealed and the content identified.</p>

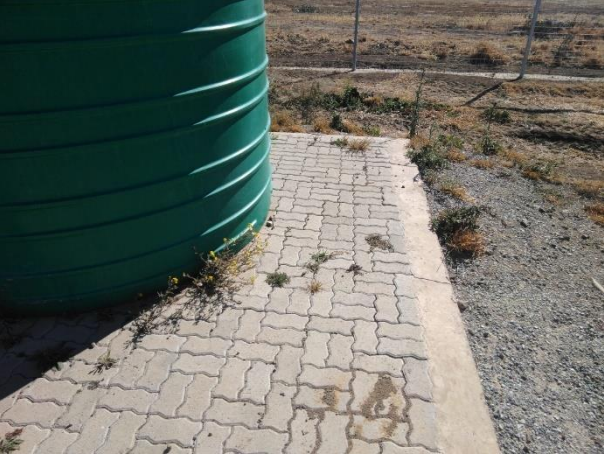
<p>24 X</p>	<p>Alien and Invasive Species were observed on site. It must be ensured that all Alien and Invasive Species are cleared inline with the relevant method statements and Alien and Invasive Management Plan.</p>
---	-----------------	--

It must be ensured that all Alien and Invasive Species within the LNG Facility is cleared in line with the Method Statements and Alien and Invasive Species Management Plan during Quarter 4 of 2024.
